THE STORMONT FIRE

SIR REGINALD DOYLE
CBE

AND FIRE SAFETY IN CROWN BUILDINGS

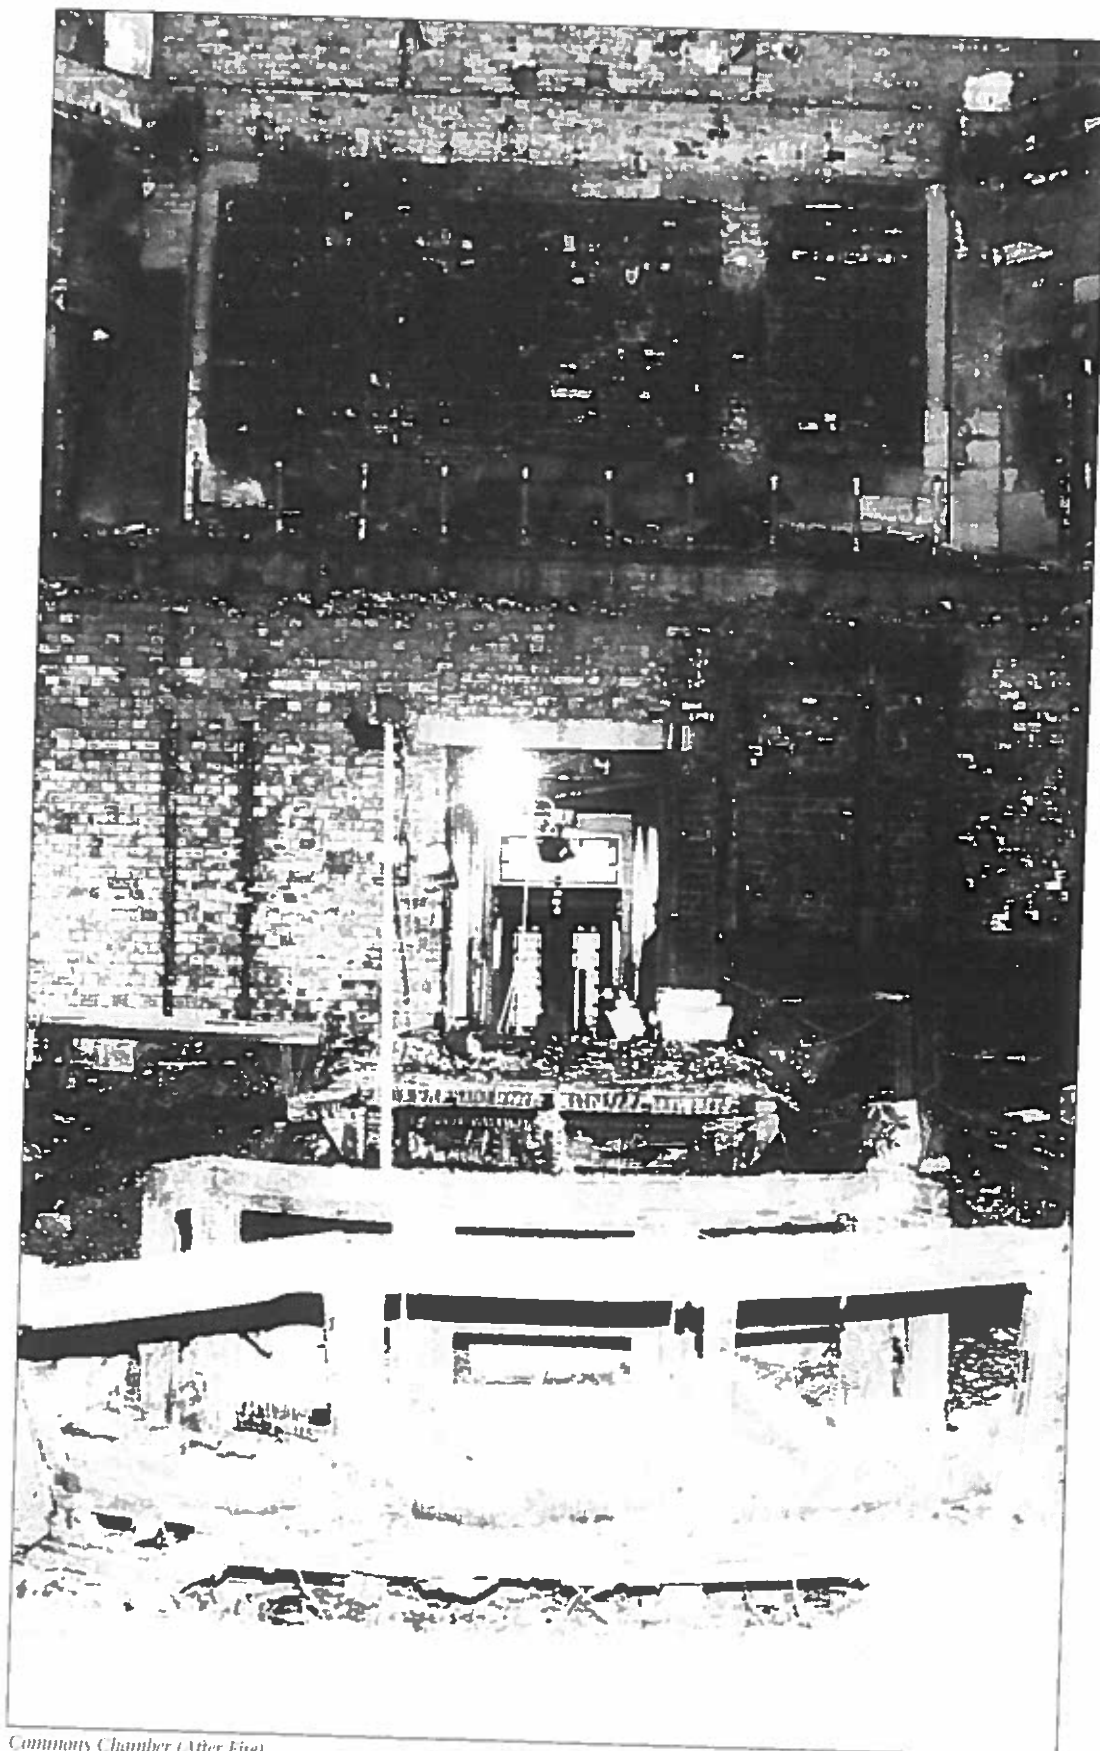
- 3.4.13 Fire damage was considerable but within the confines of the Commons Chamber, the galleries and small rooms off the press gallery. Heavy timber and glass doors had held the fire in check but were failing when the Brigade arrived. Despite the problems with water supply the strategic and timely positioning of water jets prevented the fire from spreading beyond the immediate area of the Chamber.

Commons Chamber (After Fire)

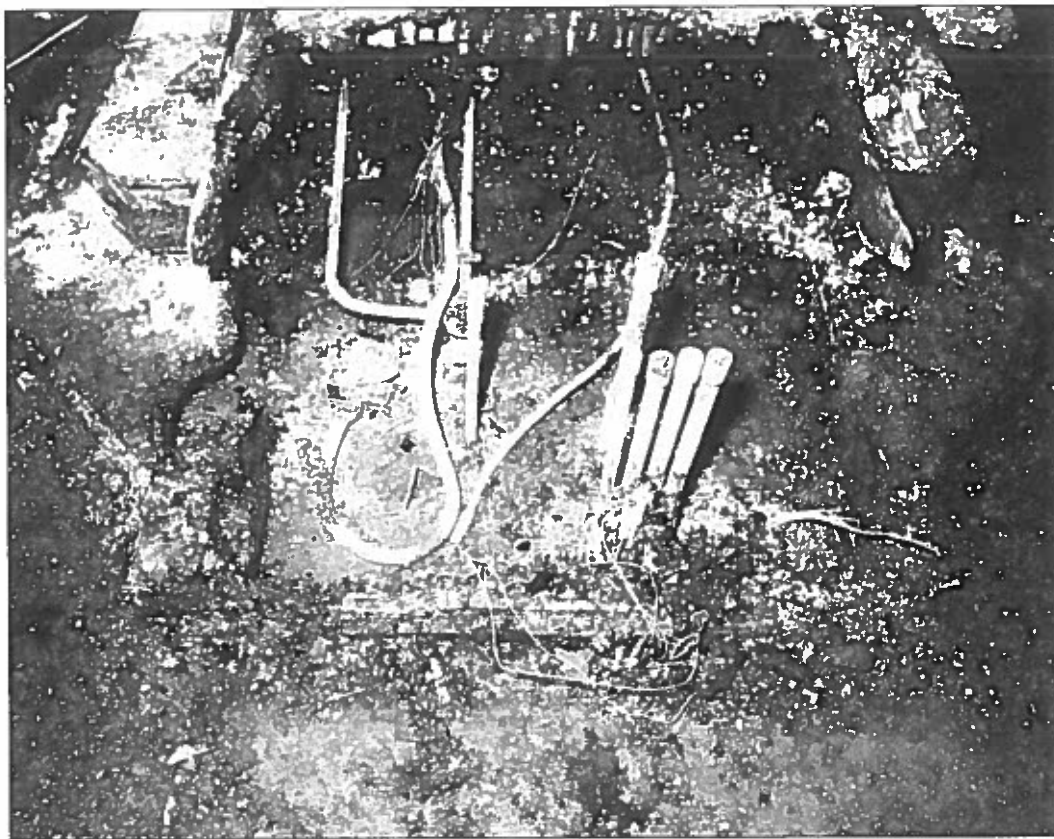
APPENDIX I.1

- 3.5.3 Deep charring of the timber at the base of the Speaker's Chair had taken place and similarly in the floor joists under the Chair (see Appendices I.1 and I.2). A section of one of the joists had been totally burnt away down to the level of the concrete floor. Charcoal was present in this area.

- 3.5.7 No evidence of any incendiary device or any flammable liquids such as petrol or paraffin had been found.
- 3.5.8 Taking into account the watchkeeper's report of having noticed an unusual smell some eight hours before the fire was detected, the deep charring of the timber at the base of the Speaker's Chair indicating a long slowly smouldering heat source, the evidence indicating an electrical short-circuit at this location and the indications that there had been a long slow build-up of heat in the Chamber it is my opinion that the most likely cause of fire was an electrical fault in the wiring below the Chair.

Conduit below Speakers Chair

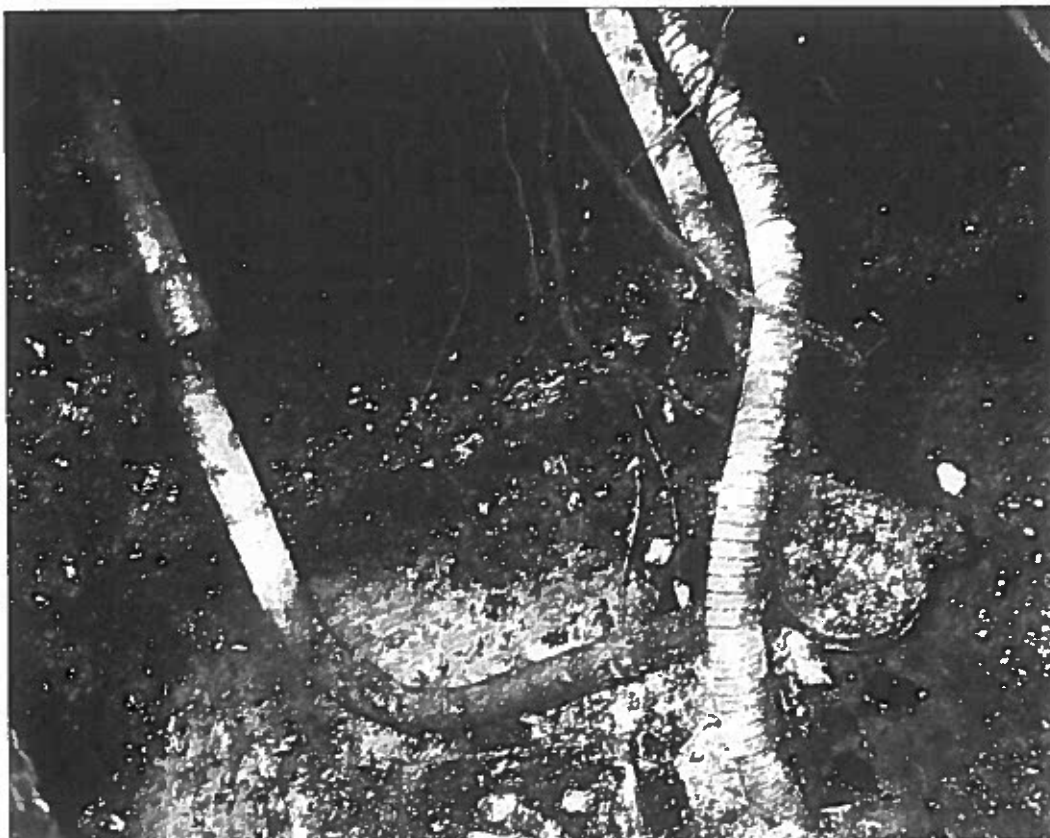
APPENDIX I.2

Open Joint in Conduit

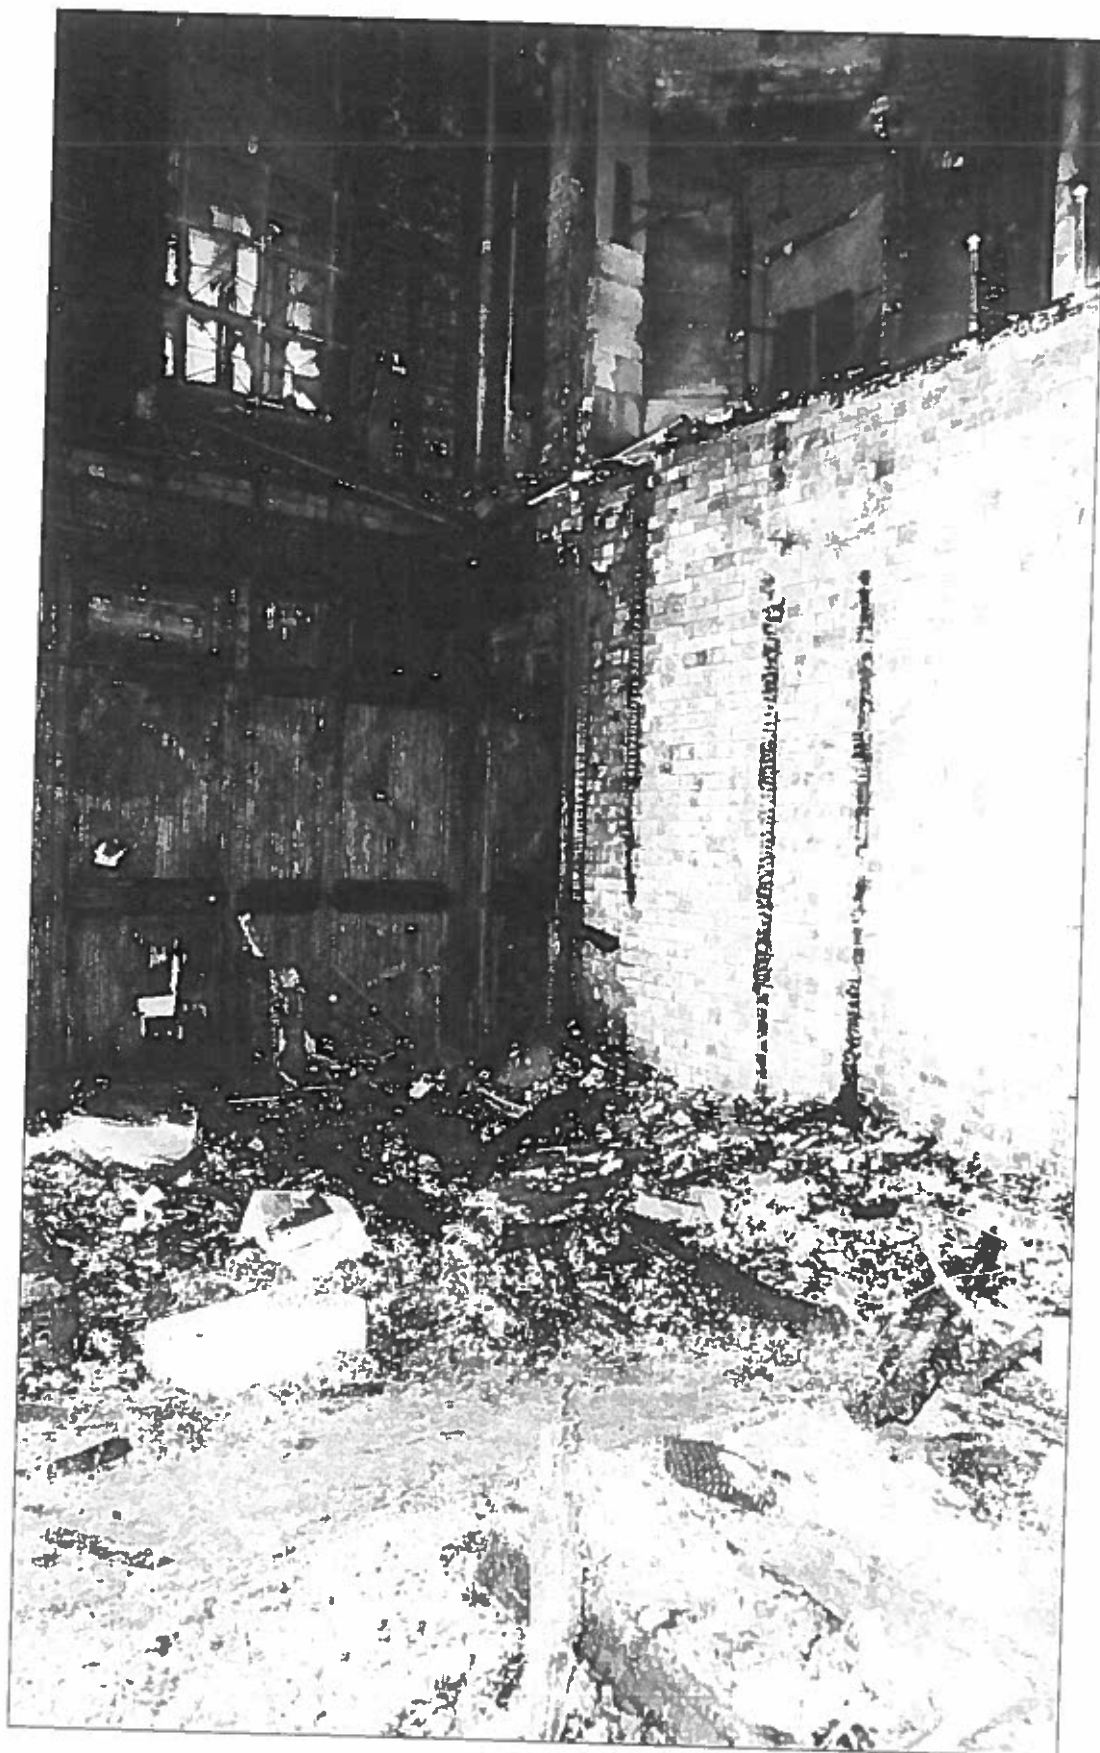
- 3.6.3 Most severe burning (above floor level) in the Chamber occurred at the south-west wall behind the Speaker's Chair. The high back to the Chair was found having fallen towards this south-west wall. The fire would then have spread along the seating. The wooden panelling on this wall was totally destroyed and the brickwork behind was seriously spalled (see Appendix J).

Spalled Brickwork

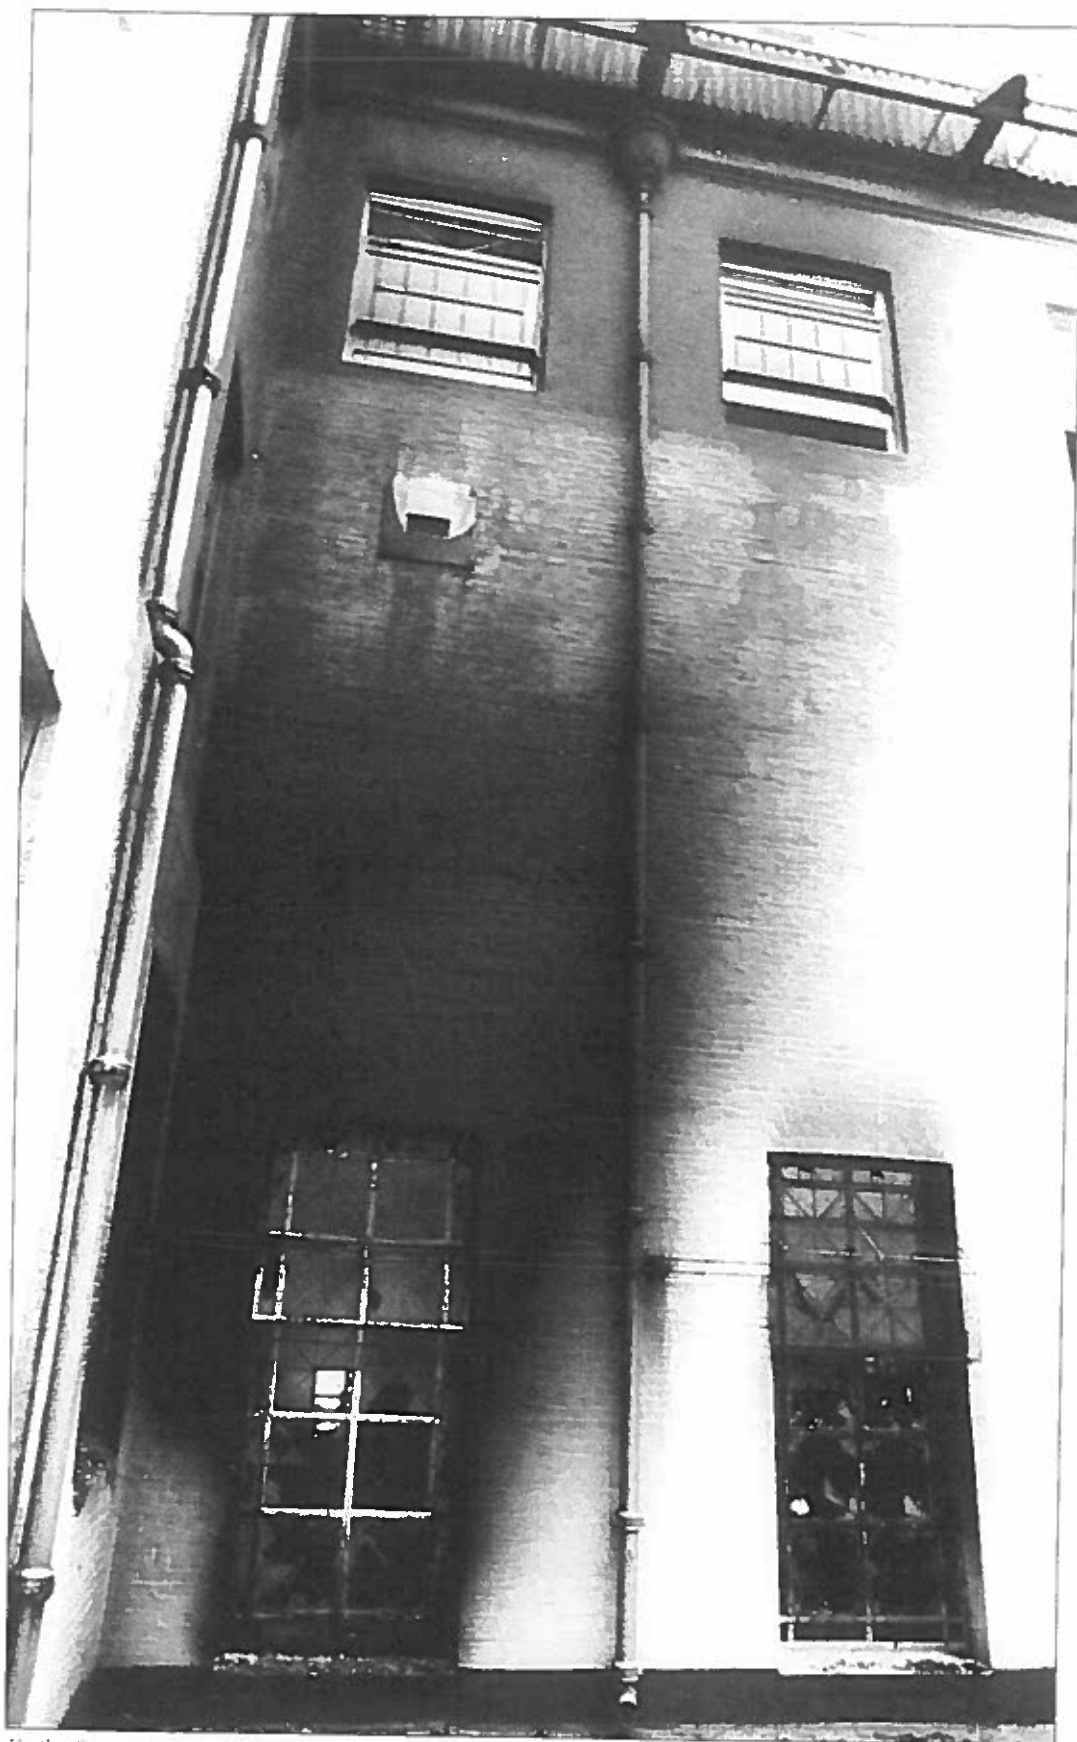
Venting from Ante-room Window

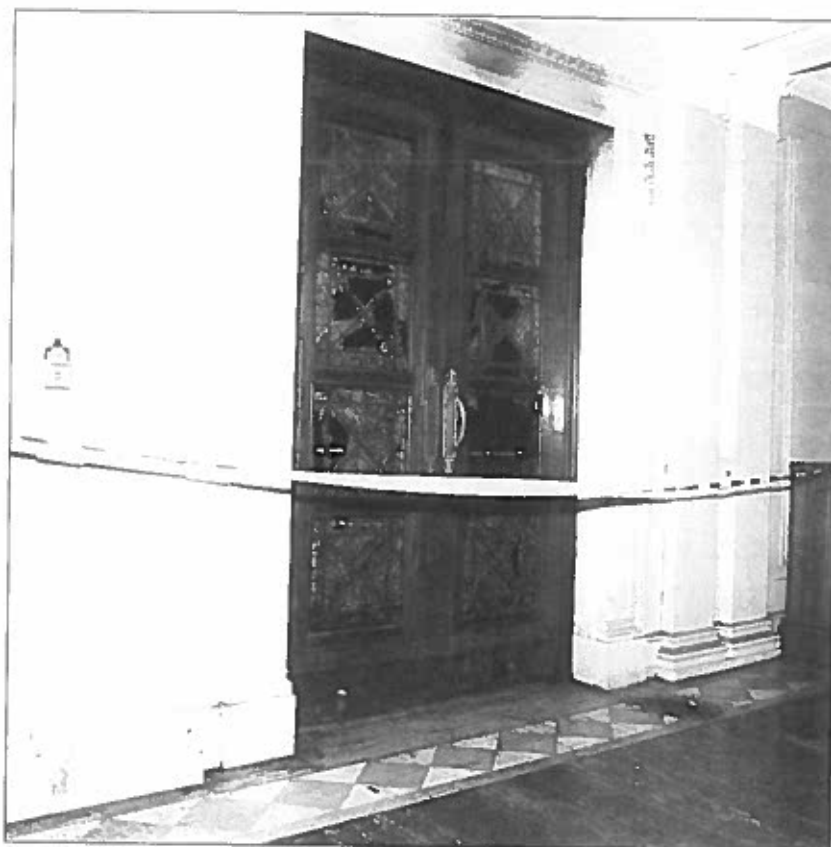
Lobby Entrance to Chamber - Outside

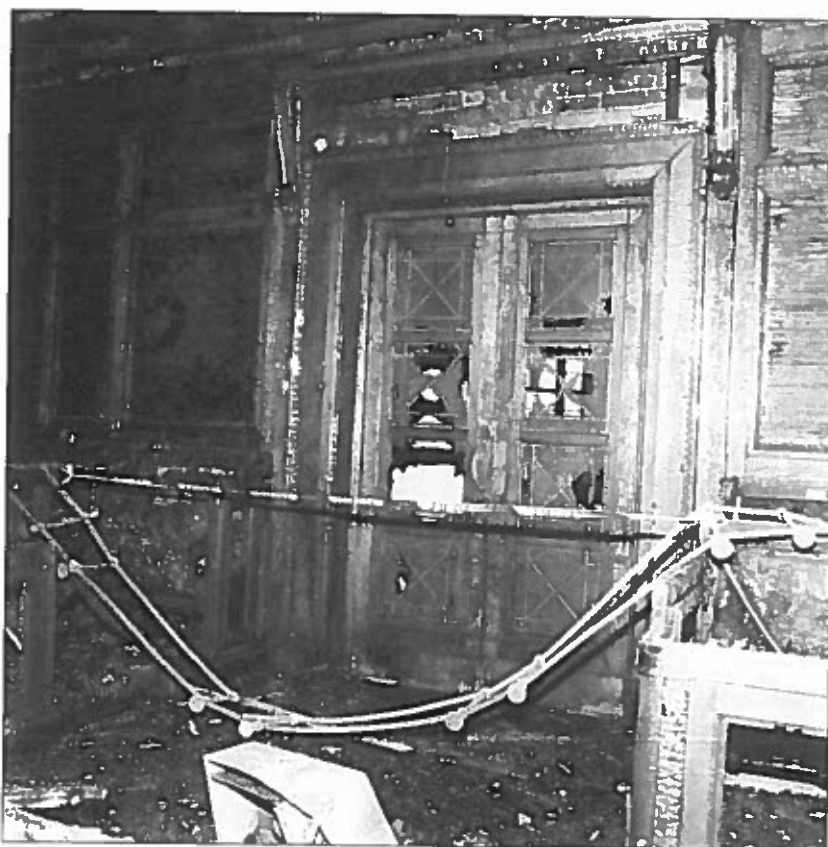
Lobby Entrance to Chamber - Inside

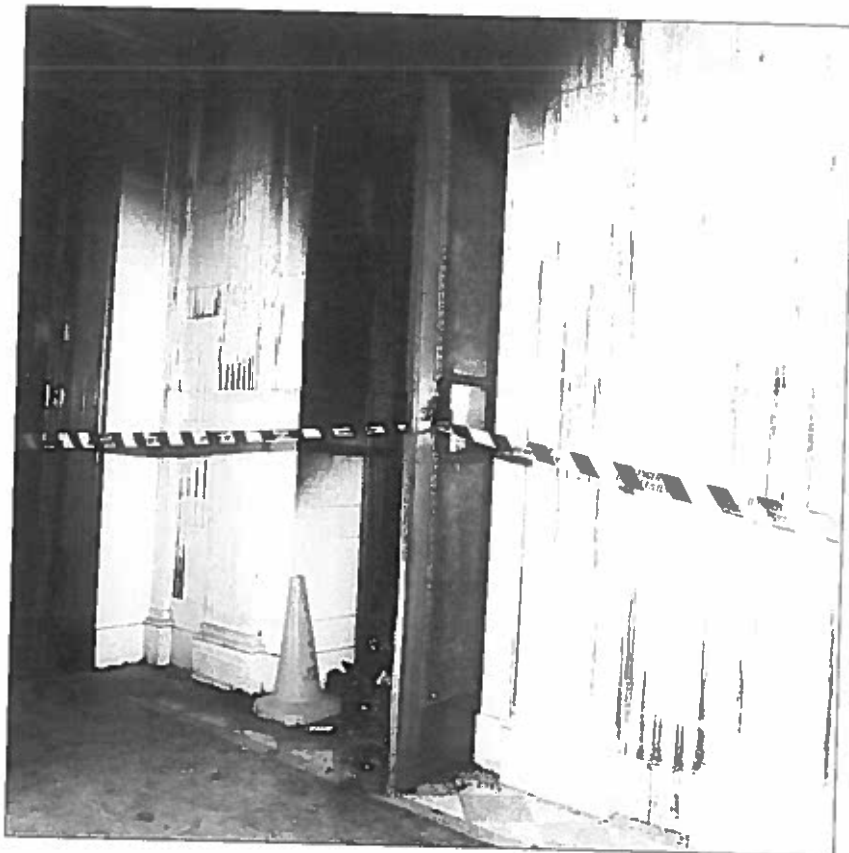
APPENDIX L.3

Division Lobby Door- Outside

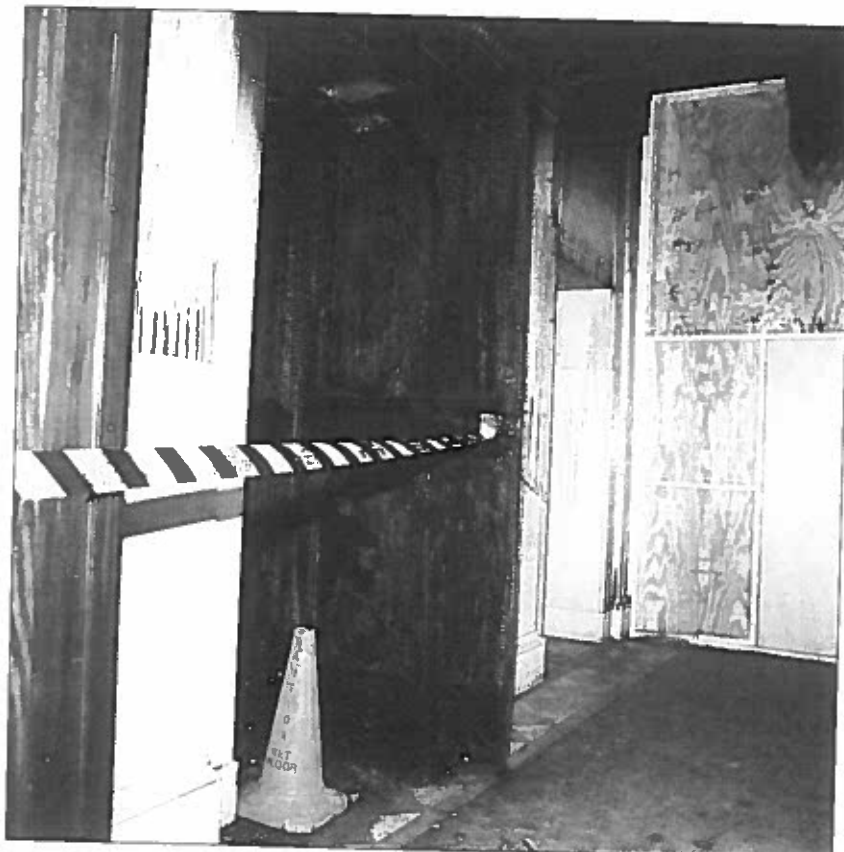
APPENDIX L.4

Division Lobby Door- Inside
