Published Project Report PPR412

Automated inspection of highway structures 2008/09

Automated inspection of highway structures

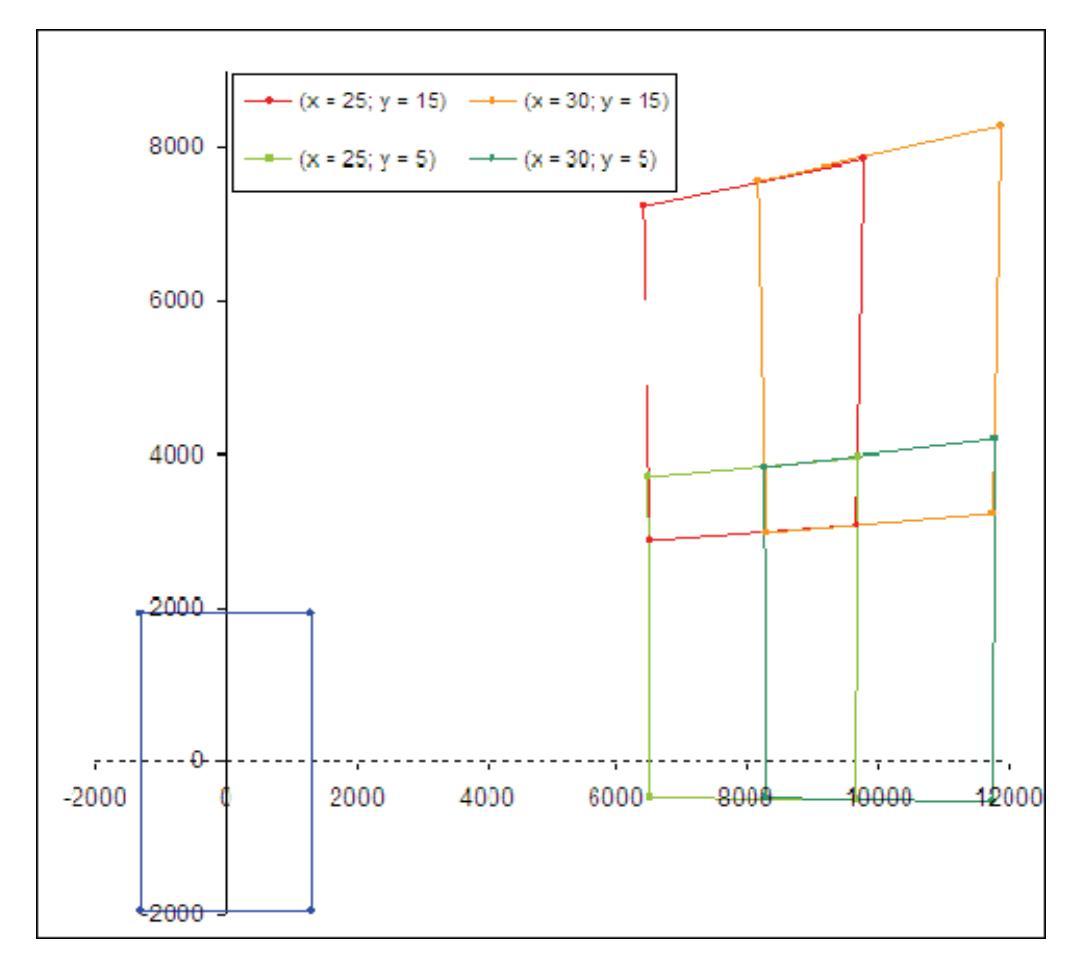
Figure 1 shows how images taken at various bearings and elevations can end up representing different sized and shaped areas of the real world, even though all will be displayed as identically sized rectangular images. The blue rectangle shows the size and shape of an imaged area if the image was taken perpendicularly to the surface being imaged. The other four shapes show the sizes and shapes of real world areas which have been imaged at various bearings and elevations.

Figure 1: Illustration of how viewing angle can affect size and shape of view represented in image.

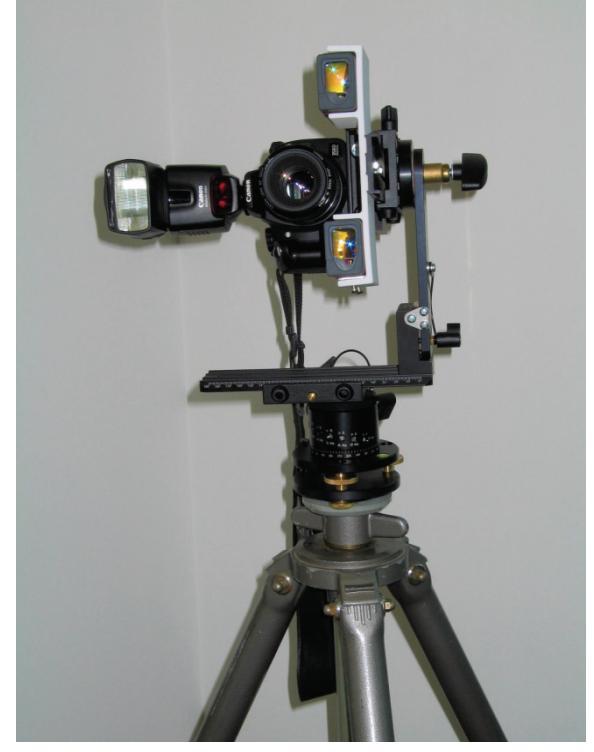
The earlier phases of this research ((McRobbie, Lodge, & Wright, 2007) and (McRobbie, 2008)) had resulted in the development of equipment, and a setup procedure for the image collection rig. The equipment was put together as shown in Figure 5.

Figure 5: Imaging rig (tripod, mounting head, camera, distance measurement lasers, laser mounting bracket)

Once correctly set up, the tripod was located such that the camera was 1.5m above the ground, in the correct location (determined using the theodolite). The camera was oriented so that it pointed perpendicularly towards the structure surface when the imaging rig was aligned at 0° horizontally and 0° vertically.

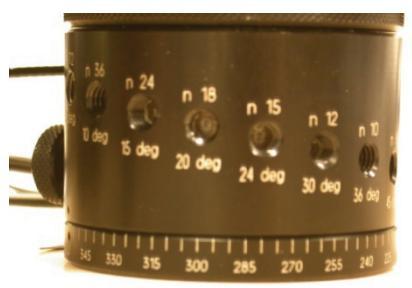
The tripod was located on the footway, in such a way as to provide minimum obstruction to pedestrian access along the footway for the public, but so that staff involved in taking the photographs and measurements were not required to leave the footway while working. The camera mounting head allows free movement vertically, but moves in discrete steps horizontally. The step size was set using the screw in the base of the head (shown in Figure 6).

Figure 6: Holes for setting horizontal rotation step on mounting head.

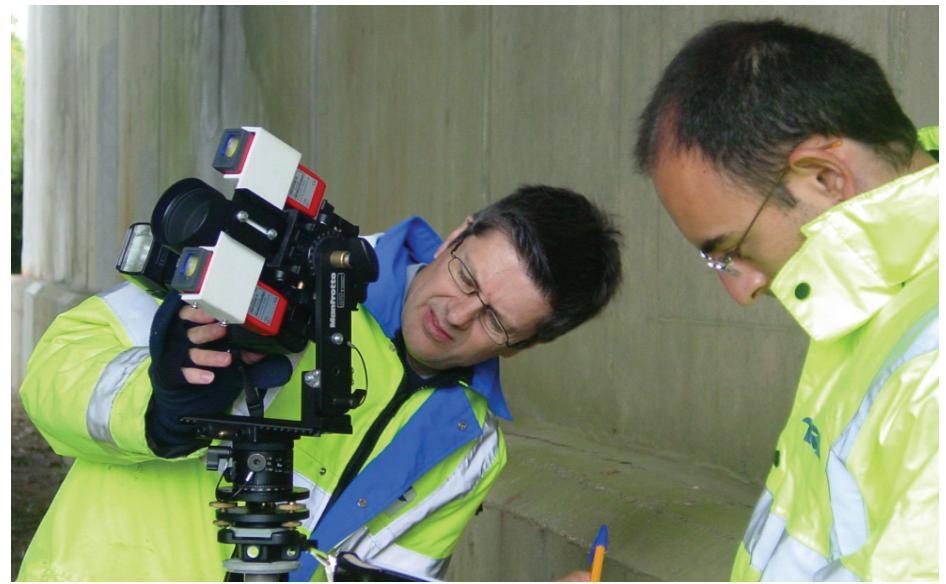
Figure 7 shows operators in the process of collecting images and noting the camera bearing and elevation, and laser distance measurements.

Figure 7: Image collection in progress (Winnersh bridge)

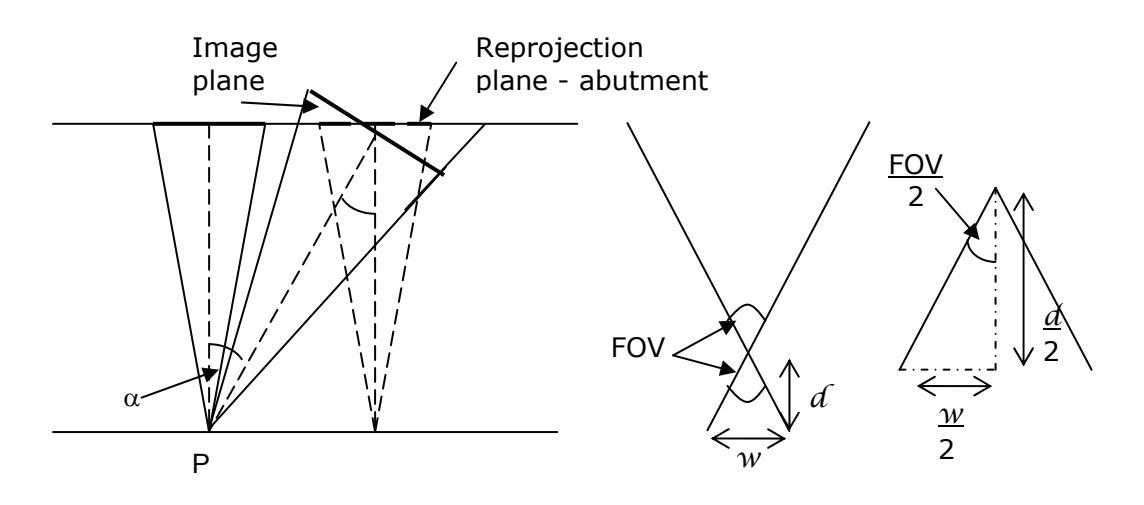
The image reprojection was performed following the trigonometric principles discussed below. Figure 8 shows a set of diagrams which are helpful in understanding the concepts involved in reprojection of images.

Figure 8: illustration of some of the concepts and angles involved in image reprojection

Image plane pan relative to projection plane:	α;
Reprojection plane tilted at:	β_r (not shown);
Image (camera) tilted at:	β_{I} (not shown).

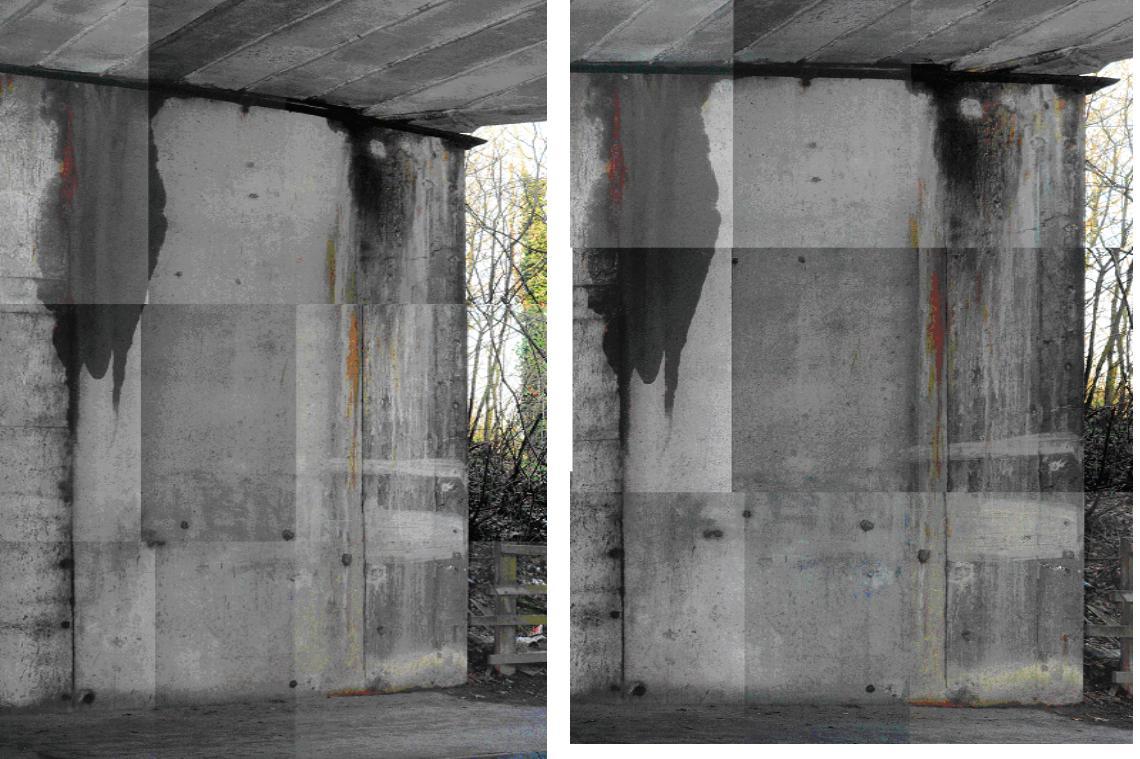
Figure 9 shows a tessellation of nine separate images with (on the right) and without (on the left) reprojecting the images.

Figure 9: Example of effect of reprojection - Mosaic of nine un-reprojected images (left) and the same nine images following reprojection (right).

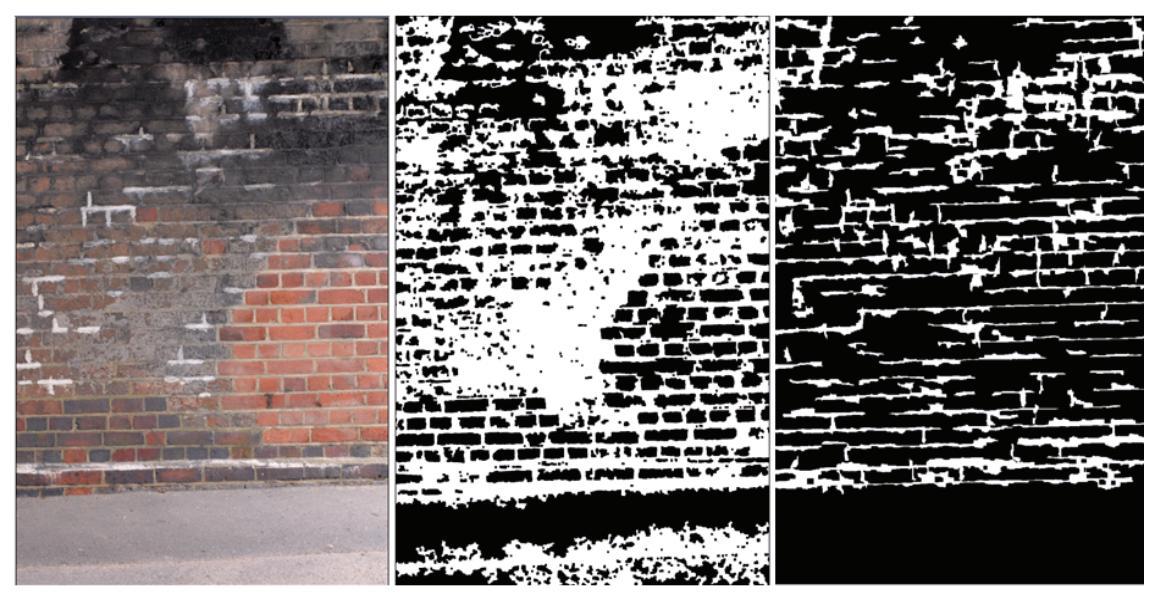
Figure 10 shows an example of a reprojected image of a masonry structure, the processed image entropy-based output of the same image, and the processed output based on the application of the Haar transform to the image.

Figure 10: Reprojected (left), entropy (centre), and Haar (right) images of a part of a masonry structure.

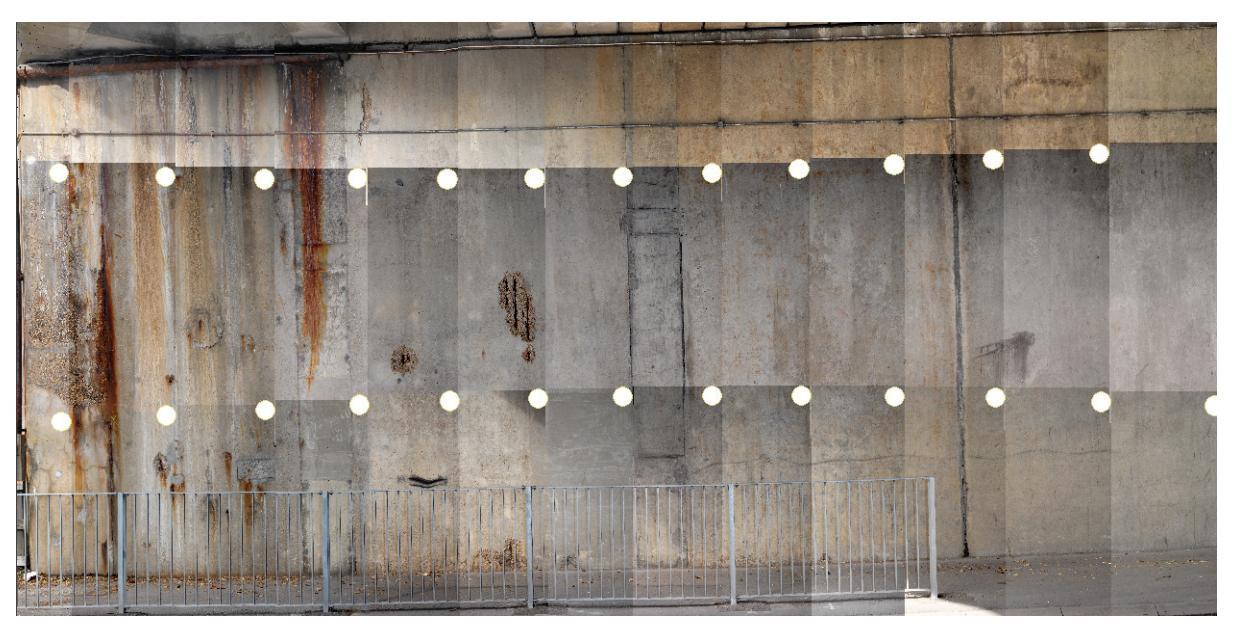
Figure 11 shows a display of tessellated, reprojected images for one of the surfaces being considered (Winnersh bridge, south end of west abutment). Figure 12 shows the reference data created for the surface shown in Figure 11. In this display red represents defects, blue and amber show features, and grey shows the edge of the surface. White areas are those where no defect was reported.

Figure 11: Tessellated, reprojected images for one of the surfaces studied

Comparison of Figure 16, and Figure 11 shows that most of the false negatives are to do with the positioning of the horizontal cable towards the top of the structure, and the horizontal lighting wire at the very top of the abutment.

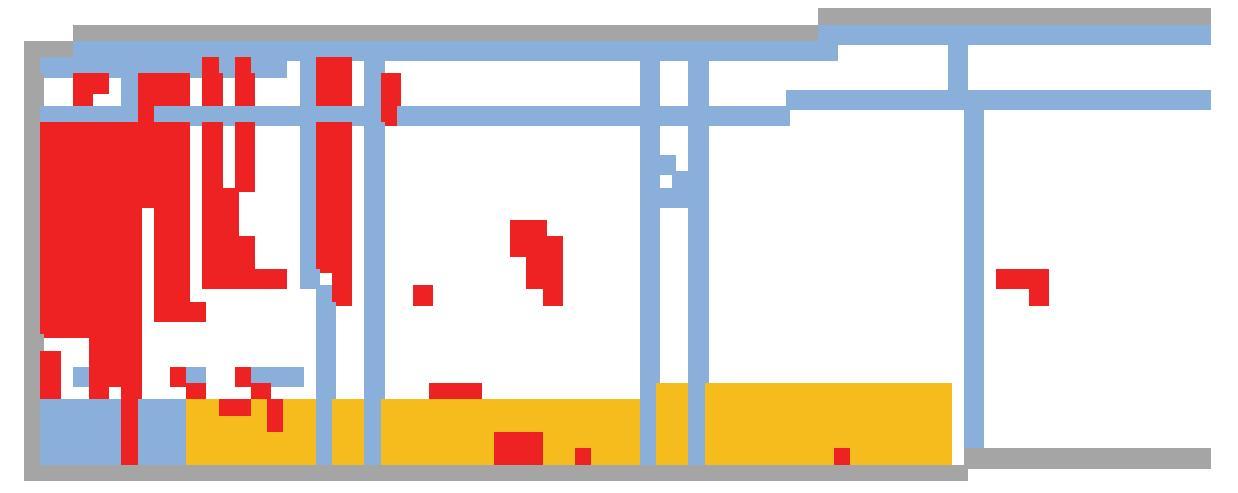
Figure 12: Reference data produced for the surface shown in Figure 11.

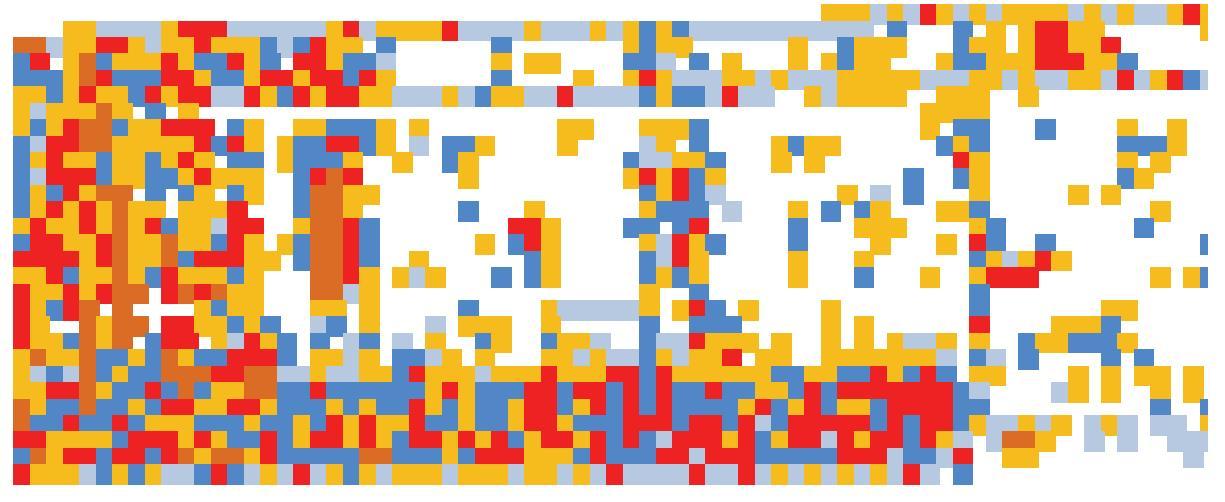
Figure 13 shows the automatically generated segmented and classified output. Here red again represents defects, brown shows rust staining, the two blue colours represent vertical and horizontal construction features, and amber shows 'other' segmented features which the system was unable to classify. White represents areas where no feature or defect was reported.

Figure 13: Automatically segmented and classified data produced for the surface shown in Figure 11.

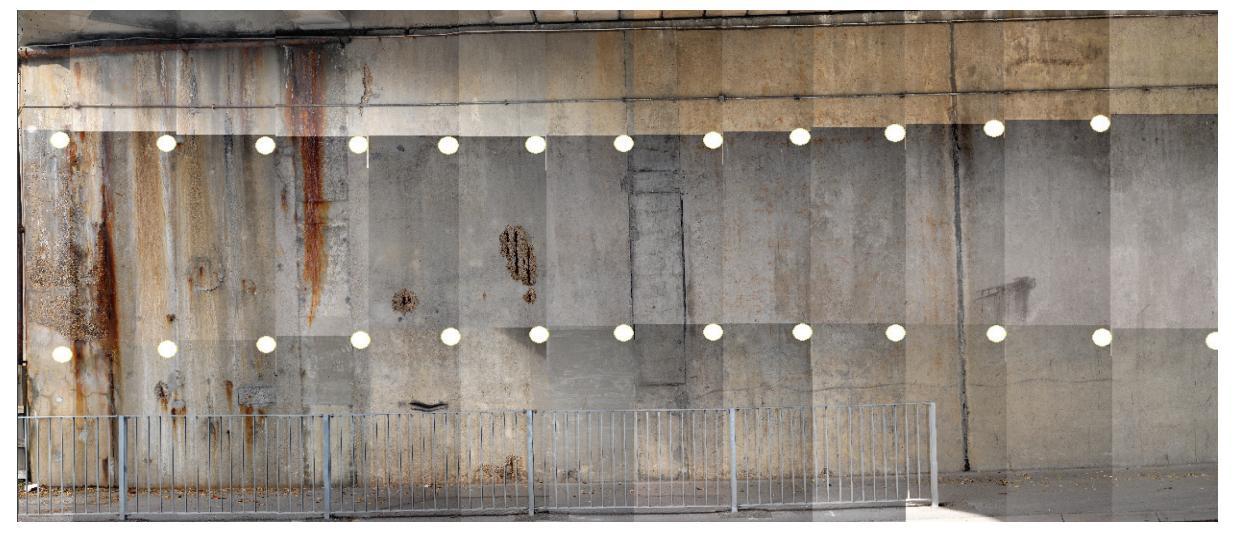
Figure 14 shows the same image as in Figure 11, represented to aid comparison with Figure 15, which shows the classifications of cells as shown in Figure 13, but this time with the colours adjusted to make the rust areas show up more clearly.

Figure 14: Tessellated, reprojected images for one of the surfaces studied

It can be seen in a comparison of Figure 14 and Figure 15 that the automatic reporting of areas of rust is quite promising, having picked up most of the cells where rust is visible in the image. It has not picked up the large spalled area in the middle of the image where the reinforcing steel is visible, but although the metal does appear to be rusty it has not stained the surface and the fact that the surface has spalled is of more significance.

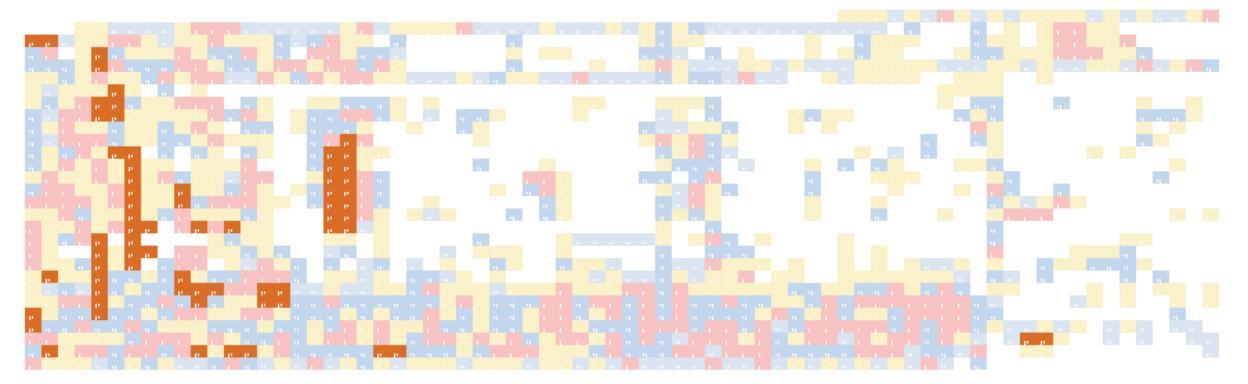
Figure 15: Automatically segmented and classified data produced for the surface shown in Figure 11, with rust areas highlighted.

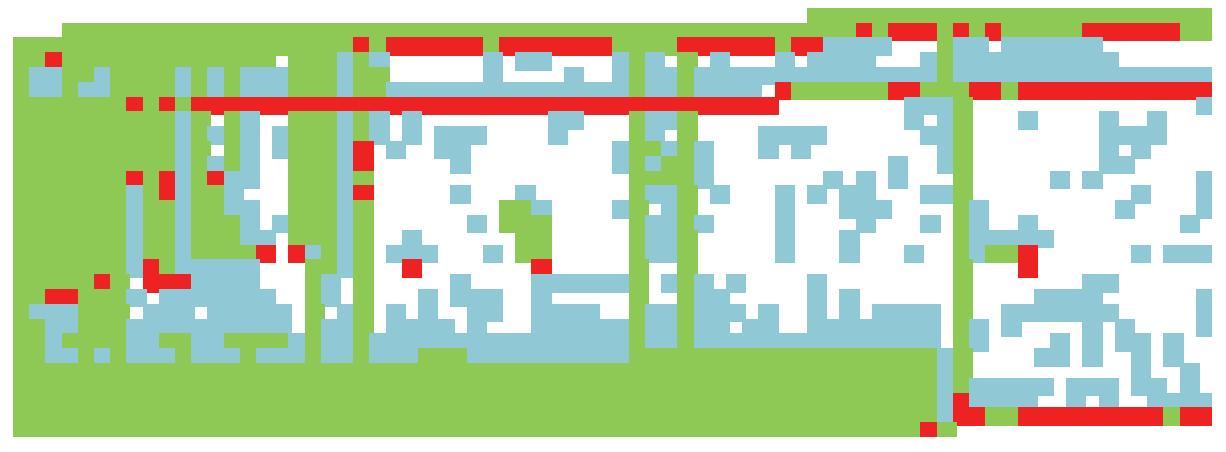
Figure 16 shows an assessment of the performance of the automated data segmentation. Green shows cells which contained something in the reference data (Figure 12) and something in the segmented automatically generated output (Figure 13). Blue shows cells which were flagged as containing something in the automatic analysis, but not in the reference data. These are false positives, and may result in the inspector being led to believe that the structure is in worse condition than is actually the case. Red represents false negatives, or cells where the automated system suggests there is no problem, but which contained something in the reference data. White

represents cells which were blank in both the reference and automatically generated data, and are successful 'hits'.

Figure 16: An assessment of the hits and misses of the automated data.
